## ANALYSIS OF HYGIENE AND SANITATION IN CHICKEN SLAUGHTERHOUSES IN JAMPANG VILLAGE, BOGOR REGENCY, WEST JAVA PROVINCE, INDONESIA

This Small and Medium Enterprise Chicken Slaughterhouse in Jampang Village is a home industry which is engaged in chicken slaughter. This home industry is located on Jl. Parung-Bogor, Jampang village, Parung sub-district, Bogor regency. Currently, the conditions of the chicken slaughterhouse have not met (SNI 01-6160-1999) in the aspects of location, equipment, construction, use of standard equipment and hand washing facilities. So that it can cause the movement of bacteria and lack of hygiene in chicken products. One of the improvement efforts made is by conducting a hygiene and sanitation analysis based on the SNI 01-6160-1999 reference.

The purpose of study is to evaluate the implementation of hygiene and sanitation of chicken slaughterhouses.

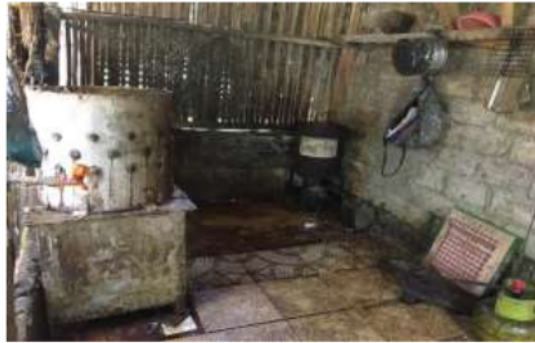
Figure 1. Construction of Chicken Slaughterhouses in Jampang Village

Table 6 shows the results of the building construction assessment where the layout is not in line with the flow of the chicken slaughtering production process due to the insufficient space, so most of the slaughtering processes are carried out close to one another. There is no clear physical separation between clean and dirty areas. The wall is not made of waterproof and corrosive material. The floor is not made of materials that are not waterproof, slippery, corrosive, and not perforated. The roof of the

building is watertight and has no holes. The building construction has not been designed to be rodent free. Good ventilation is more than 10% of floor area. Buildings have not been cleaned and disinfected regularly every 2 weeks.

According to SNI 01-6160-1999, the layout must be designed so that it is in line with the process flow and has sufficient space so that all poultry slaughtering activities can run well and hygienically. The size of the room must also be adjusted to the cutting capacity. There are no clear boundaries between dirty and clean areas. So that workers are free to enter clean and dirty areas. This will cause cross-contamination through the skin, rumen fluids, blood, and labor of the carcass. So that the carcass produced and marketed becomes unsafe and unhealthy for consumption (Rohyati, 2017). A picture of the production room of a chicken slaughterhouse in Jampang Village can be seen in Figure 1. The chicken slaughterhouse building does not meet the requirements for walls and floors, as can be seen in Figure 1. This requirement is not fulfilled, among others, because there is a wall made of brick which is only roughened, without any more layers so that the material is not waterproof and has the potential to grow moss around the walls.

checks, standard equipment must be met, sanitary buildings made separate from living quarters. In addition, spatial planning is improved in the direction of the process flow, there is a clear physical separation between clean and dirty areas. Walls and floors in buildings must be designed to be waterproof, not easily corrosive. The building construction is made rodent-free and disinfected every two weeks to maintain cleanliness. The completeness of the building must have an employee rest area, a place for storing personal items, and generating sets. Sanitation facilities must be fulfilled, one of which is a means of washing hands and providing soap, a cloth / hand drier as a hand dryer. Carcass tools can be replaced with tools made from stainless steel. The carcass must also be cleaned using detergent every day. The chicken coop should be cleaned and washed regularly. The carcass is placed on a waterproof mat and not the cutting floor, the chicken carcass should be temporarily stored in a closed container after which it is burned.

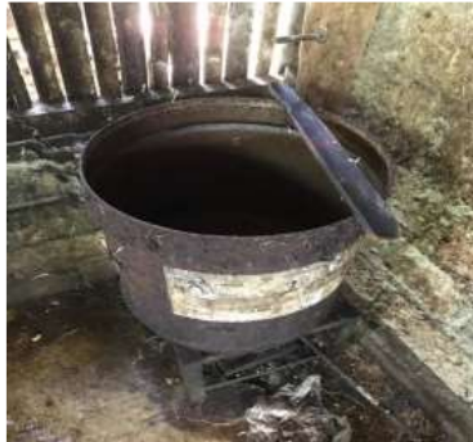
Figure 2. Equipment for a Chicken Slaughterhouse Dipping Pot in Jampang Village

Table 12 shows that the pot utensils used are corroded. The pot that is used is washed every day. Pans used but never washed using detergent. This condition can cause microbes to contaminate broiler chickens such as salmonella (Aerita *et al.*, 2014). The pan equipment used can be seen in Figure 2.

According to SNI 01-6160-1999, equipment that is directly related to meat must be made of non-toxic, non-corrosive, easy to clean and densified and easy to care for.

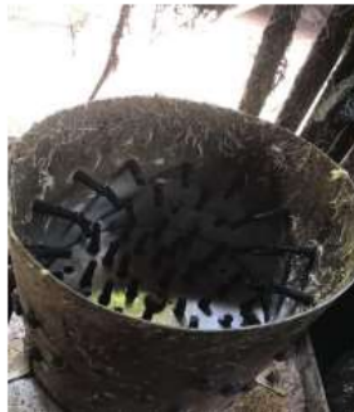
Figure 3. Feather removal tool for a chicken slaughterhouse in Jampang village

Table 13 shows that the hair removal tool used is corroded. Feather pluckers used in chicken slaughterhouses are washed every day. Hair removal tools that are used but never washed using detergent. Table 14 shows distribution of variable assessment results for poultry cages in slaughterhouses in Jampang Village

Table 13 shows that the hair removal tool used in chicken slaughterhouses can be seen in Figure 3. The hair removal tool used in
